# SPECIAL CIRCUMSTANCE

## ON-SITE REVIEW REPORT

### ***Lincoln County Facilities***

September 2021

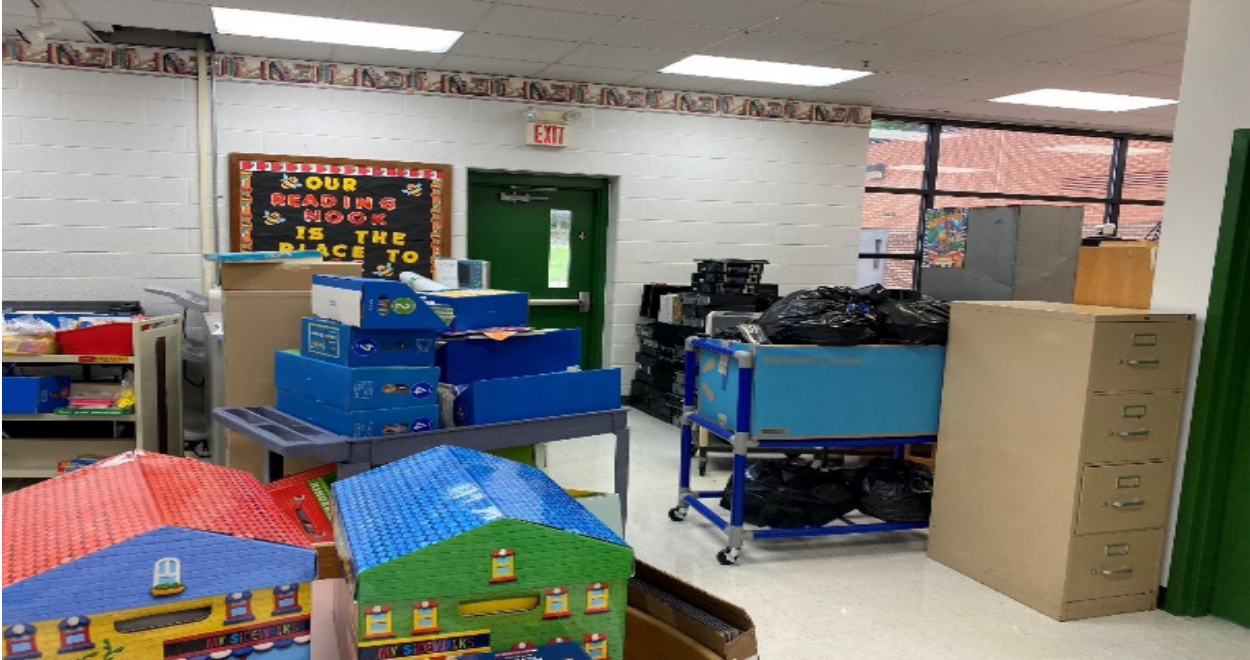
**Figure 1**

- The asbestos and pest management plans were found to be accessible, current, properly labeled, and tabbed for easy review.
- Multiple emergency egress paths and stairwells contained stored items, furniture or equipment that impede emergency egress. WV State Fire Code does not permit items, either temporary or permanent, to be located in these areas. (Photo Appendix, Figures 1 and 2)

Emergency egress blocked in West Hamlin Elementary Media Center

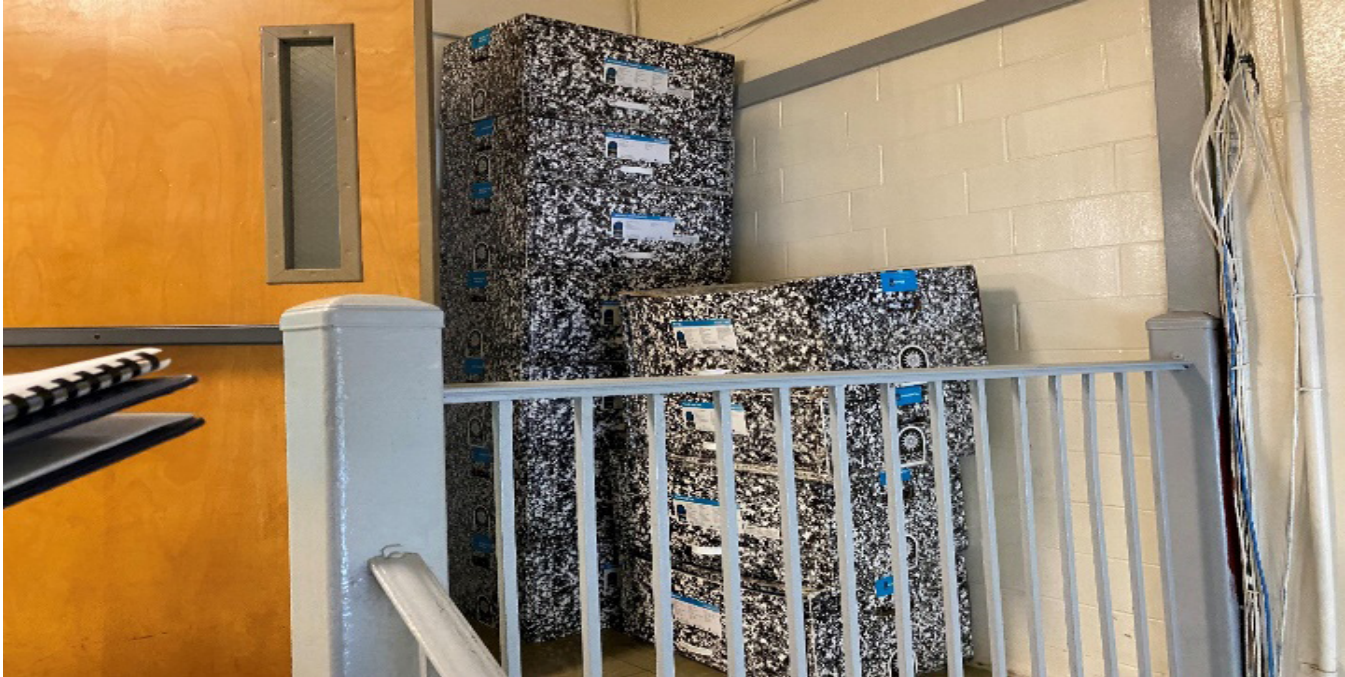
**Figure 2**

Emergency egress blocked at Midway Elementary School

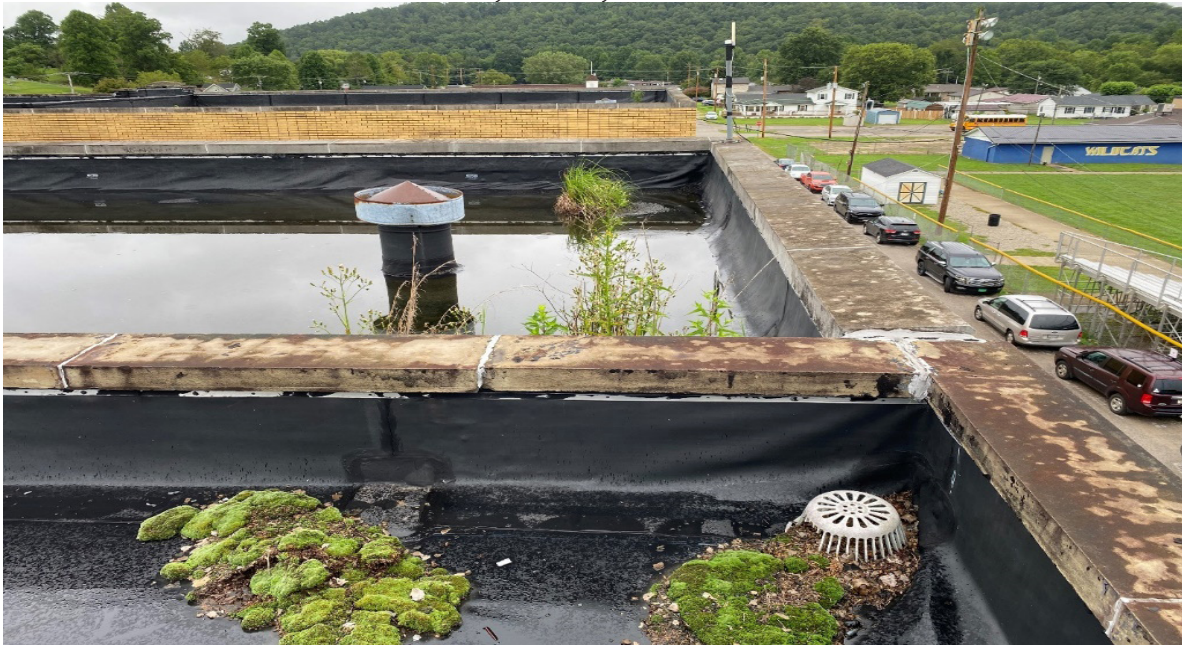
**Figure 3**

- Roofs across the county have not been appropriately maintained. The Team observed multiple examples of vegetation growth, various kinds of debris, and obstructed roof drains. (Photo Appendix, Figure 3)

- The roof area has several areas of vegetation growth and roof drains are substantially blocked by vegetation, causing large areas of ponding water. A large volume of water on the roof may damage the structure and cause roof leaks. Vegetation on the roof membranes prematurely degrades the rubber materials. (See Photo Appendix Figure 3)

Vegetation and blocked drains on the roof at Guyan Valley Middle School

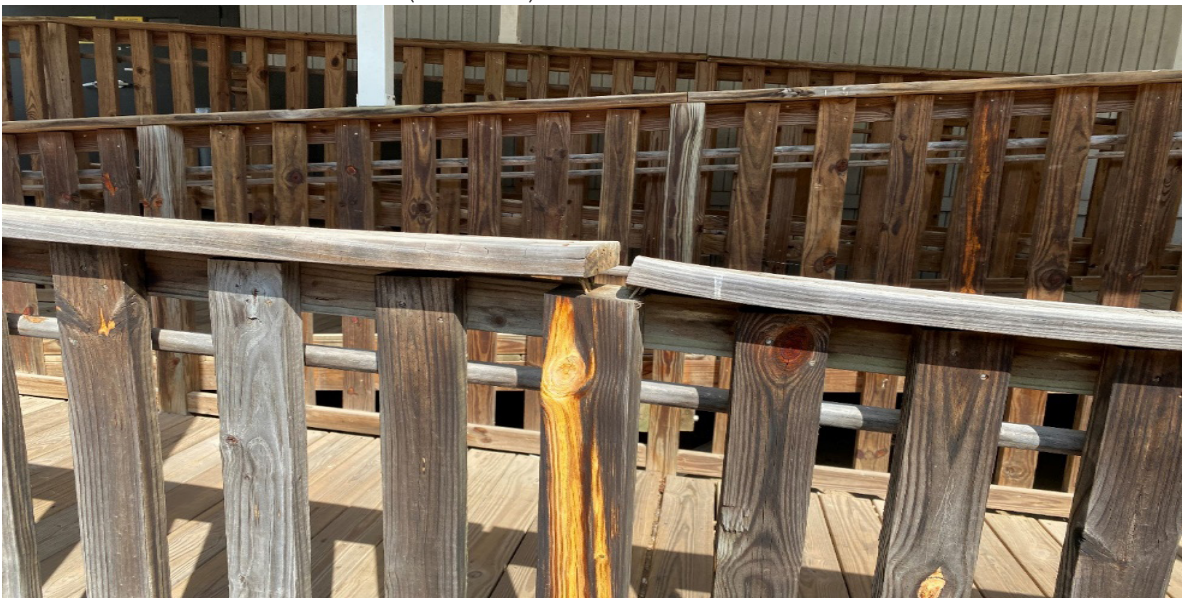
**Figure 4**

- The access panel for the crawl space had been removed and was leaning against the building.
- Sections of the handrail on the front deck are failing, presenting a safety hazard. (Photo Appendix Figure 4)

Handrail on the front deck at Duval PK-2 (Portables)

- Install cameras and monitoring equipment to observe entry and exit into the building. Consideration may be given to installing a door alarm to notify staff in the event of any unauthorized exit.
- Provide a means of drainage to adequately remove water from the perimeter of the facility.
- Thermostats should not permit occupants control of the outdoor air supply fan. Consideration may be given to replacing existing thermostats and/or adapting the current building automation system to control the units in the correct manner.
- Replace missing access panel in order to prevent unauthorized access.
- Repair or replace deck to prevent injury to staff and students.

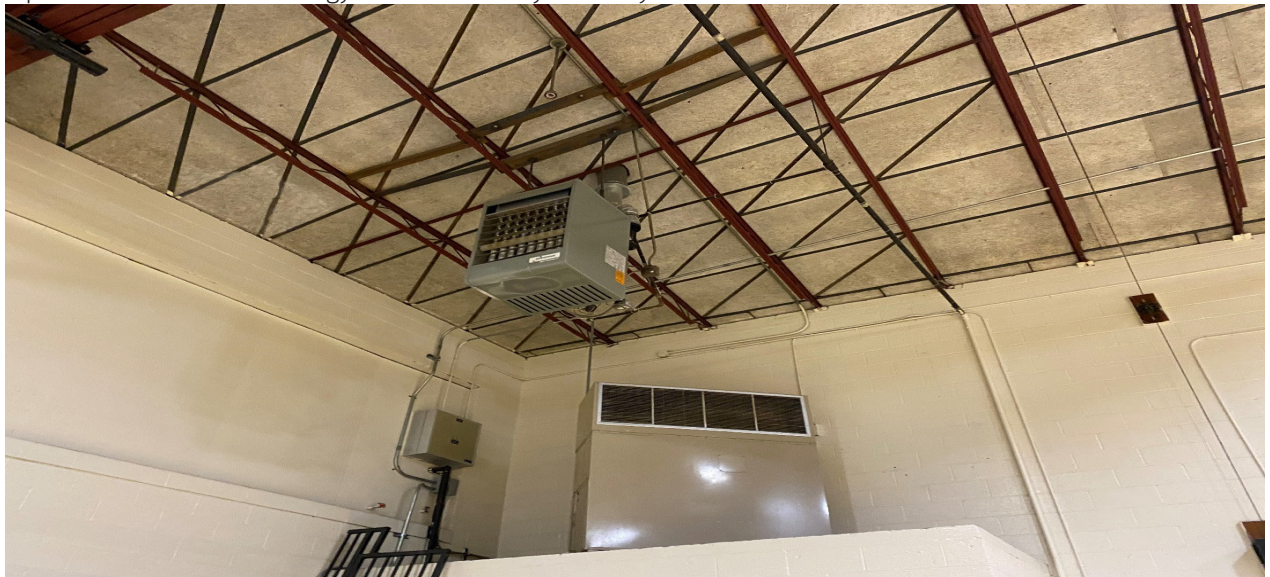
**Figure 5**

- One of the unit heaters in the gymnasium has a hot spot on the bottom of the unit, which typically indicates a failure of the heat exchanger. Cracked heat exchangers cause carbon monoxide gases to be introduced into the occupied spaces. (Photo Appendix Figure 5)

Hot spot on unit heater in the gymnasium at Guyan Valley Middle School

- Renovate the facility and grounds to comply with ADA requirements.
- Replace the current HVAC system and controls with systems that meet ASHRAE 62.1 and 90.1 Standards, as required by W. Va. Code.
- Inspect the heat exchanger in the gym and replace if needed.
- Replace the breaker box front panel to prevent access and reduce the risk of electrocution.
- Install controls to properly regulate the heat.
- Replace the corroded union as soon as possible.
- Remove all vegetation on the roof and around the drains and place this task on a routine maintenance interval.
- Replace the failed and missing light fixtures to restore proper lighting levels to the gymnasium.

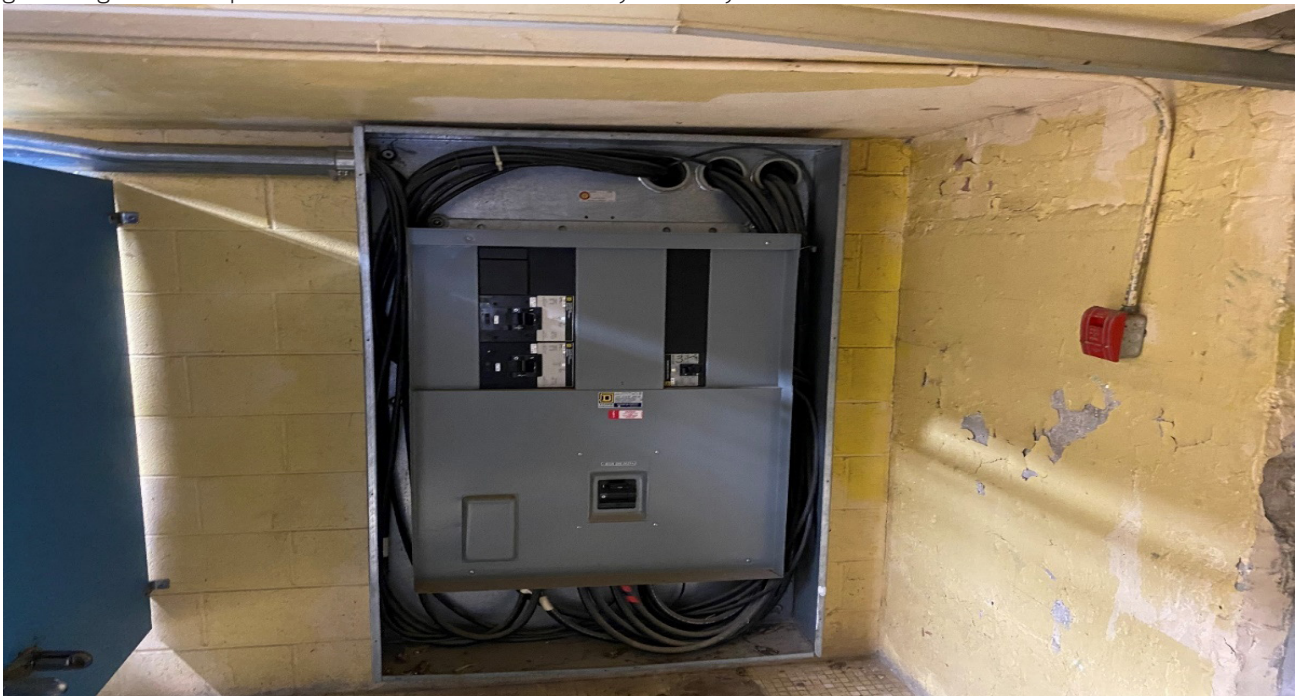
**Figure 6**

- A high voltage breaker panel box in the basement is missing the front cover, thereby exposing the electrical busses. (Photo Appendix Figure 6)
- The union on one of the heating loop hydronic heaters is badly corroded and is at risk for a major failure. (Photo Appendix Figure 7)

High voltage breaker panel box in the basement of Guyan Valley Middle School

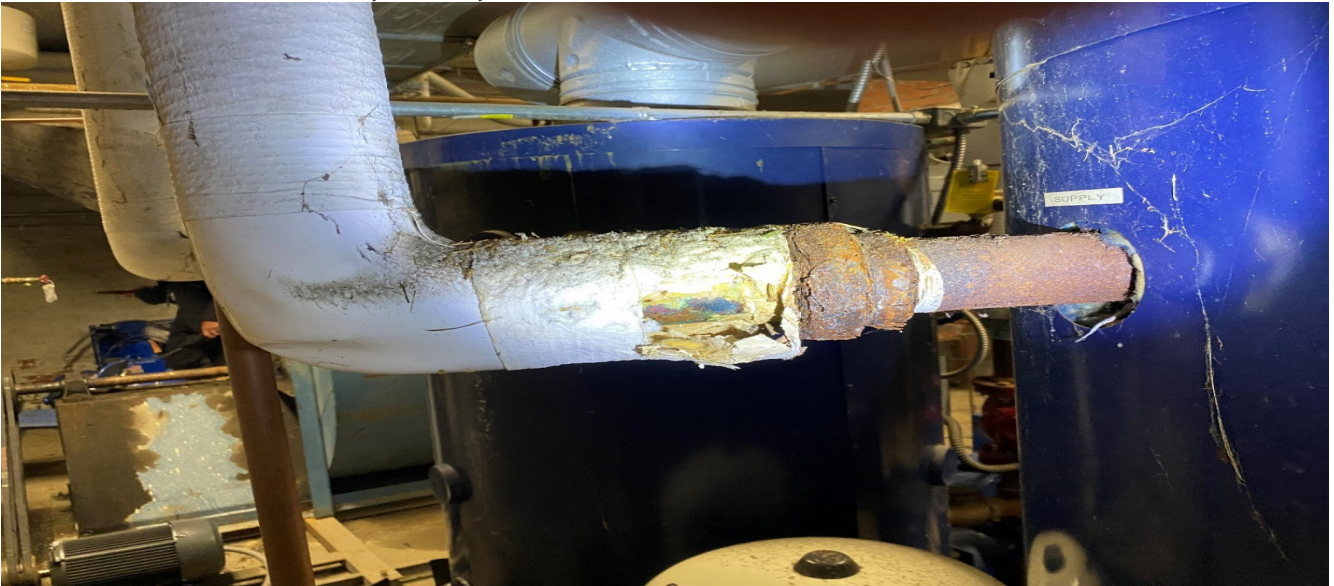
**Figure 7**

Corroded union on heater at Guyan Valley Middle School

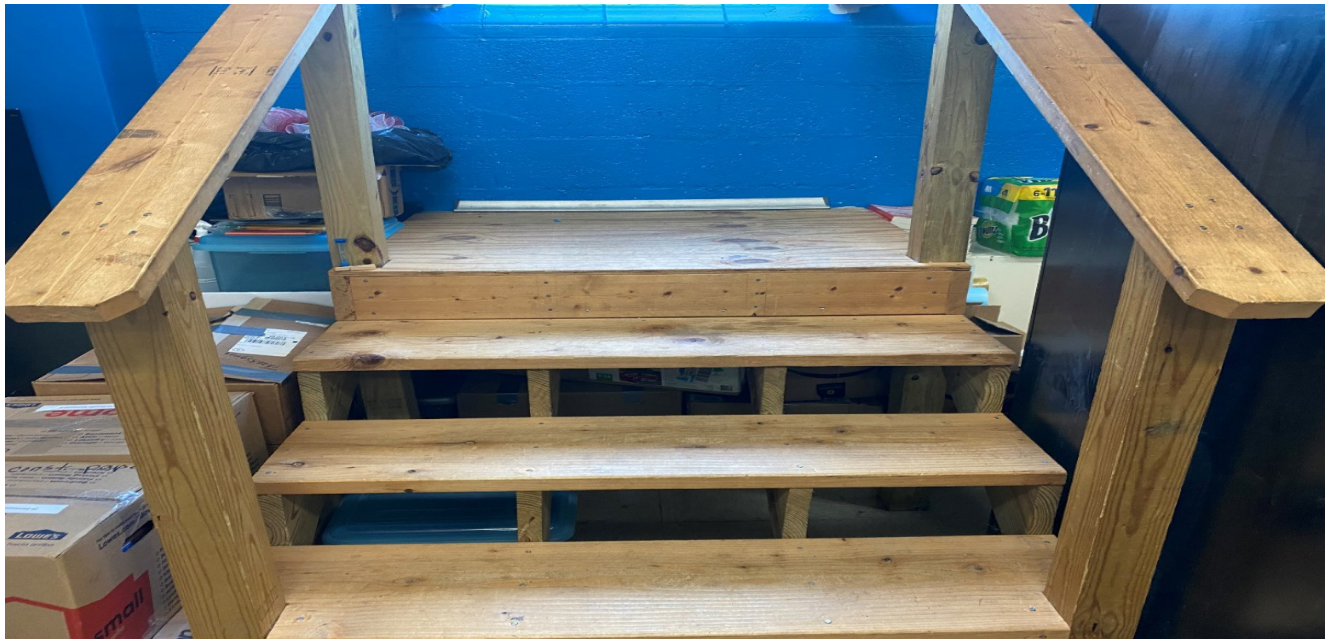
**Figure 8**

- The handle on the emergency shut off valve in Room 102 is broken.
- The wooden stairs in Room B4 were built to be used for emergency exits, but they do not meet the building code requirements for exit stairs. The emergency exit door for Room B1 is sticking and does not have panic door hardware for emergency egress. (Photo Appendix Figure 8)

Wooden stairs in Room B4 at Hamlin PK-8

- Replace the broken valve handle.
- Revise the stairs to meet WV State Fire Code and install grabbable handrails, balusters and risers on the stair treads.

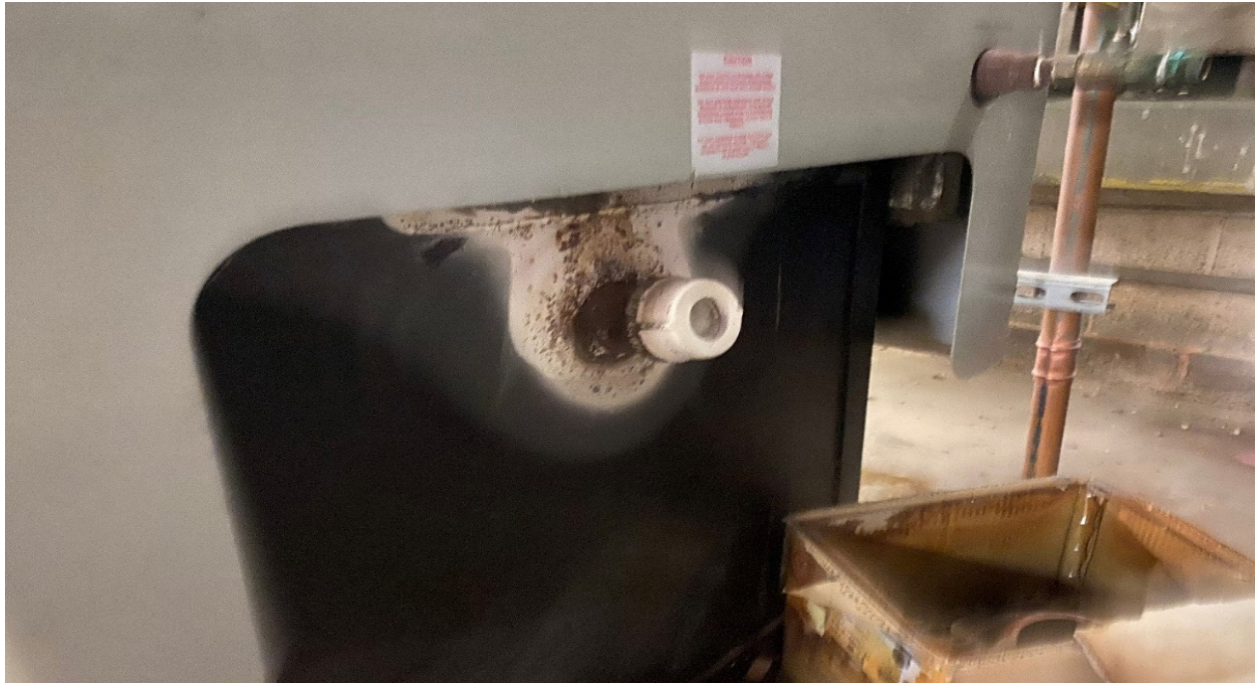
**Figure 9**

- There is an active leak from the ceiling in Room B1 from the HVAC unit above.
- Numerous issues were discovered in the boiler room. The temperature and pressure relief valve on Boiler #1 is improperly plumbed to a plastic 55-gallon drum. A portion of insulation has been removed from the chilled water side stream filter causing water to condense on the unit. Evidence of high temperatures was discovered around the sight glass on the rear of Boiler #2. Standing water was observed on the floor around the sink. (Photo Appendix Figures 9, 10, 11)

Boiler at Hamlin PreK-8

- Plumb the drain on the T&P valve to a floor drain that terminates with 6" of the floor as required by plumbing code. Replace the missing or damaged insulation and instruct maintenance staff that insulation must always be reinstalled upon completion of a repair. Inspect the boiler operation and check for cracked fire bricks that may be allowing the metal at the base of the boilers to become excessively hot.

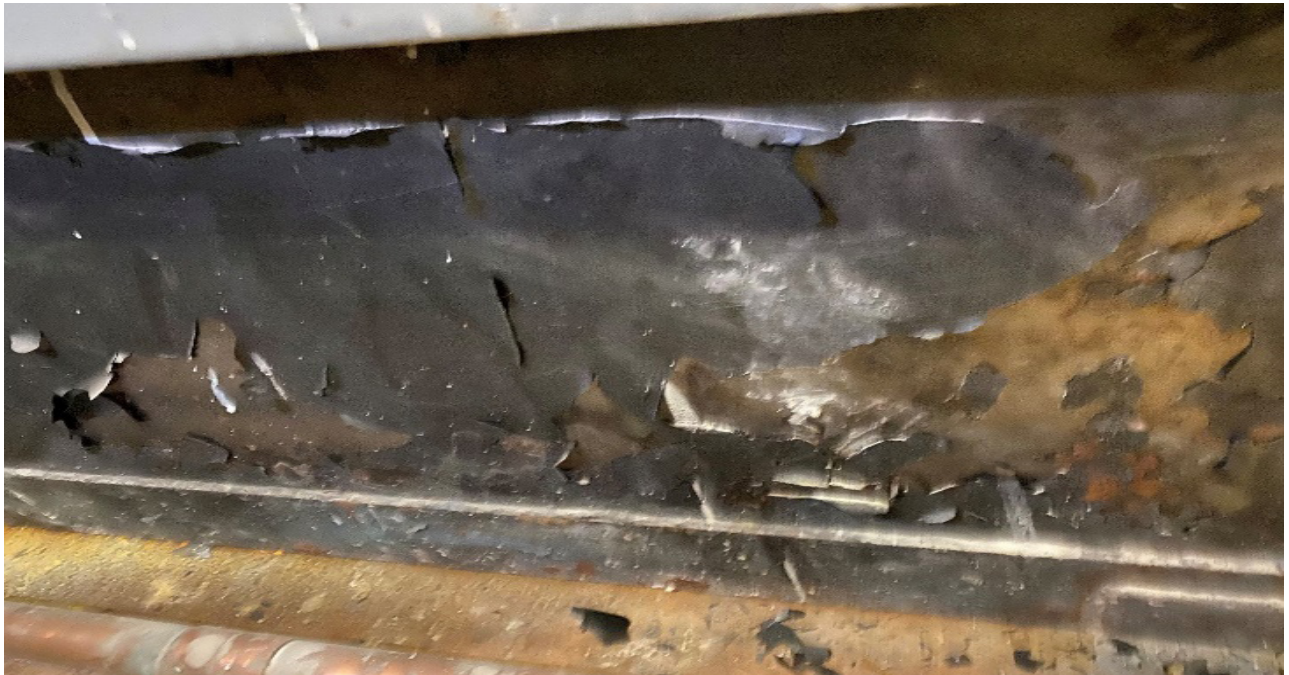
**Figure 10**

Boiler at Hamlin PreK-8

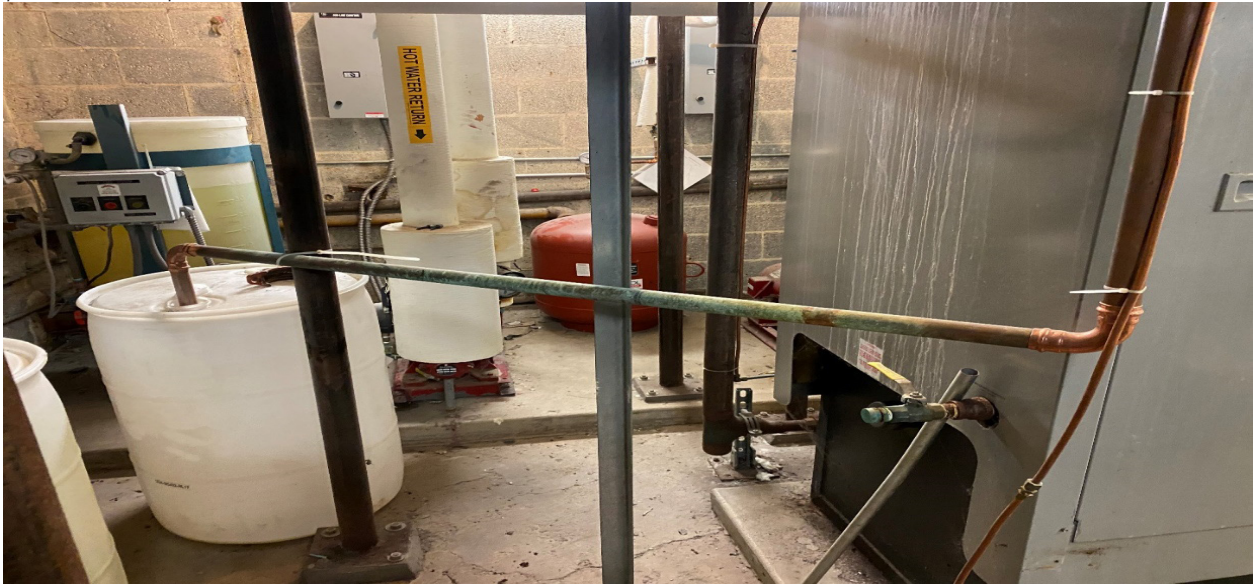
**Figure 11**

Temperature and pressure relief valve at Hamlin PreK-8

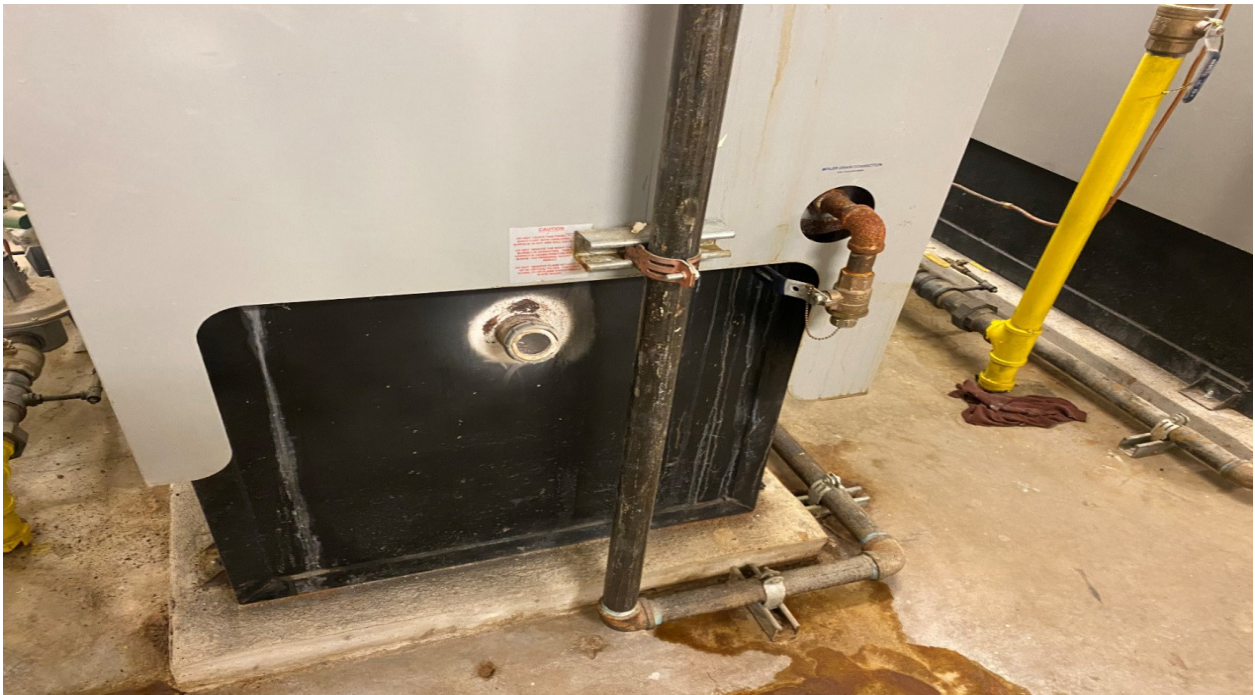
**Figure 12**

- There is evidence of high temperatures around the sight glass on the rear of the boilers due to over firing. (Photo Appendix Figure 12)
- There is a leak in the domestic water line near the hot water tanks in the boiler room. There is no acid neutralizing media in the condensate drain device for the domestic water heaters.

Boiler #2 at Harts PK-8

- Inspect the boiler operation and check for cracked fire bricks that may be allowing the metal at the base of the boilers to become excessively hot.
- Repair the water leak in the domestic water line in the boiler room.
- Replace the acid neutralization media in the condensate lines of the domestic water heaters to prevent corrosion to the drain lines of the facility. The media is a consumable item and must be replaced at scheduled intervals. Place this task on a routine maintenance schedule.
- Correct the time and date on the fire alarm system. Task school staff with monitoring the panel to ensure that the time and date are correct.
- Repair the roof leaks and replace all stained or missing ceiling tiles.
- Fire doors should not be physically held open as they are required to close on activation of the fire alarm system. Repair the magnetic hold back that normally keeps this door open.

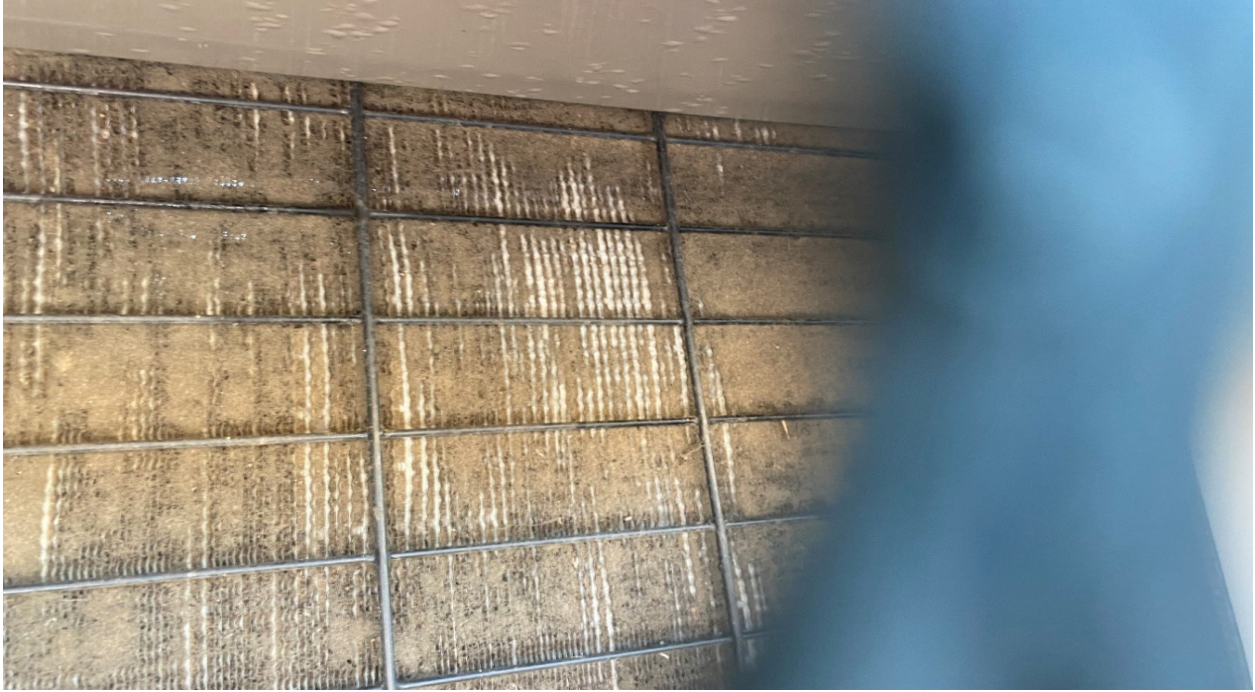
**Figure 13**

- The condition of the HVAC equipment and controls indicates poor maintenance and housekeeping practices. The last date on the maintenance log was 2016. The chilled water coils for the rooftop HVAC units are very loaded. Interior insulation on the units is loose and being entrained into the breathing zone. Several air filters had fallen out of the filter rack on the roof top units. (Photo Appendix Figures 13 and 14)

Chilled water coils at Lincoln County High School

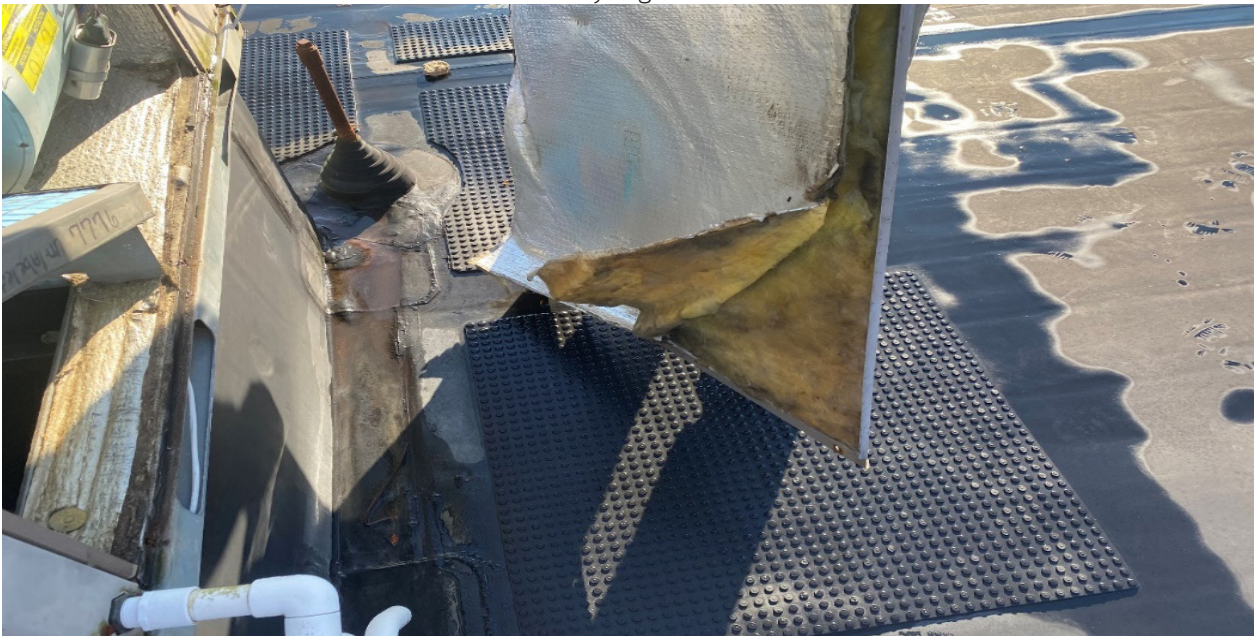
**Figure 12**

Interior insulation on the HVAC units at Lincoln County High School

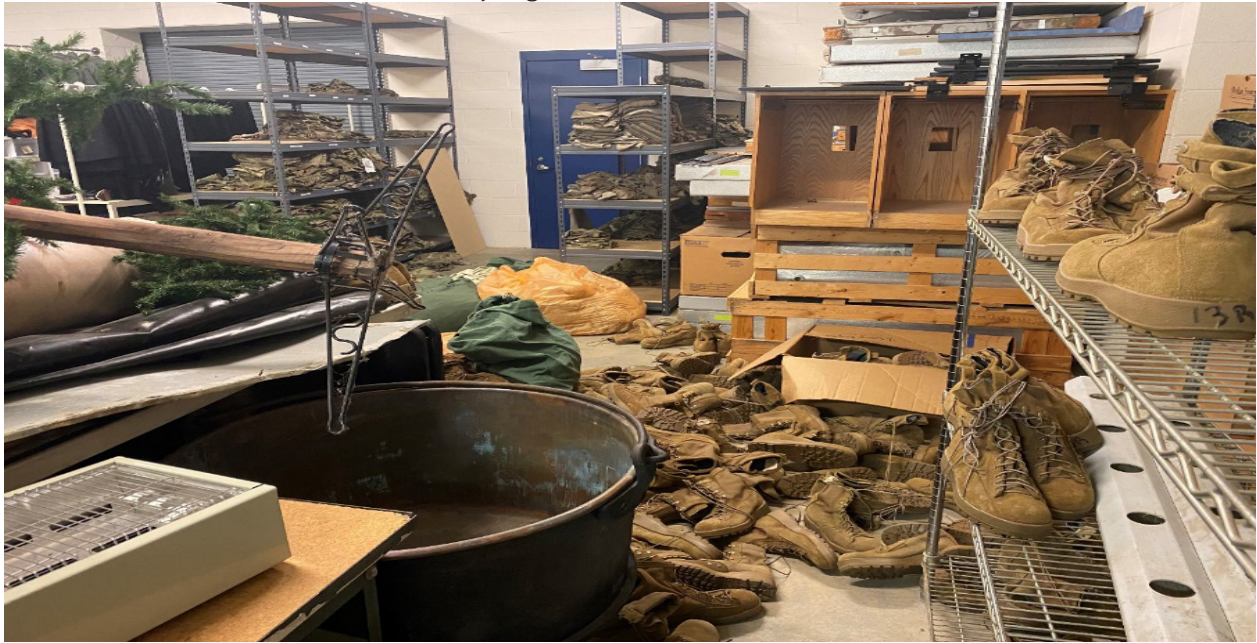
**Figure 15**

ROTC classroom mezzanine at Lincoln County High School

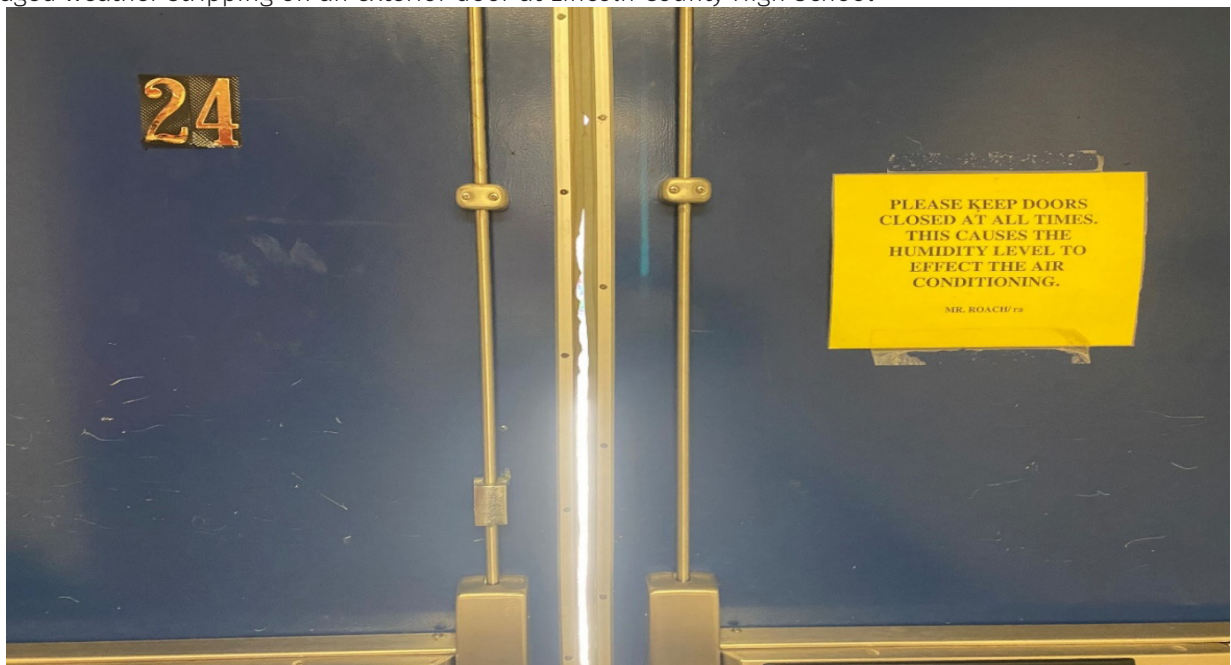
**Figure 16**

Damaged weather stripping on an exterior door at Lincoln County High School

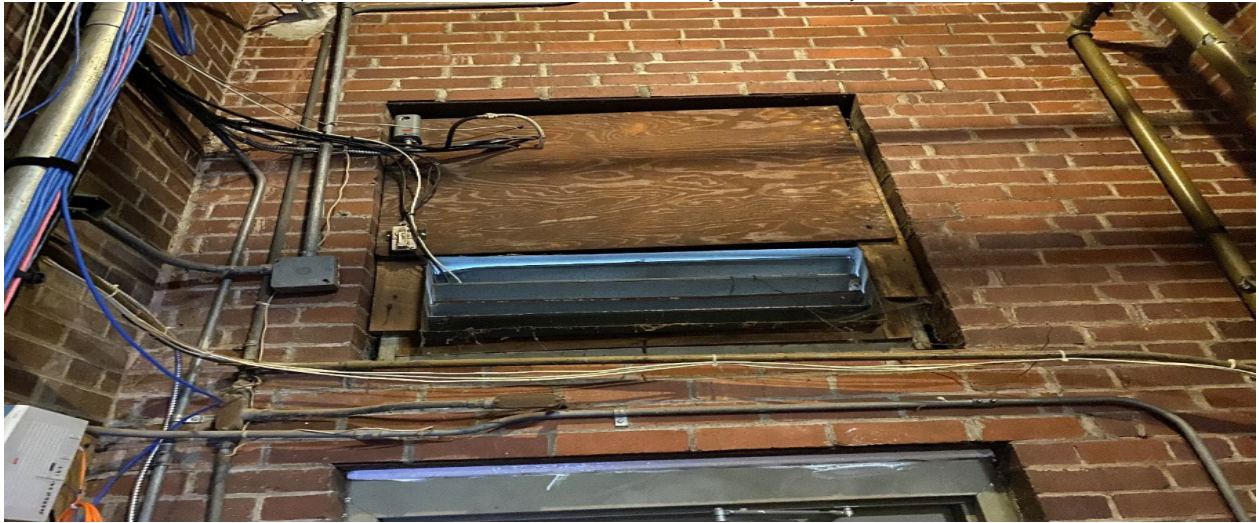
**Figure 17**

Blocked combustion air dampers in the furnace room at Midway Elementary

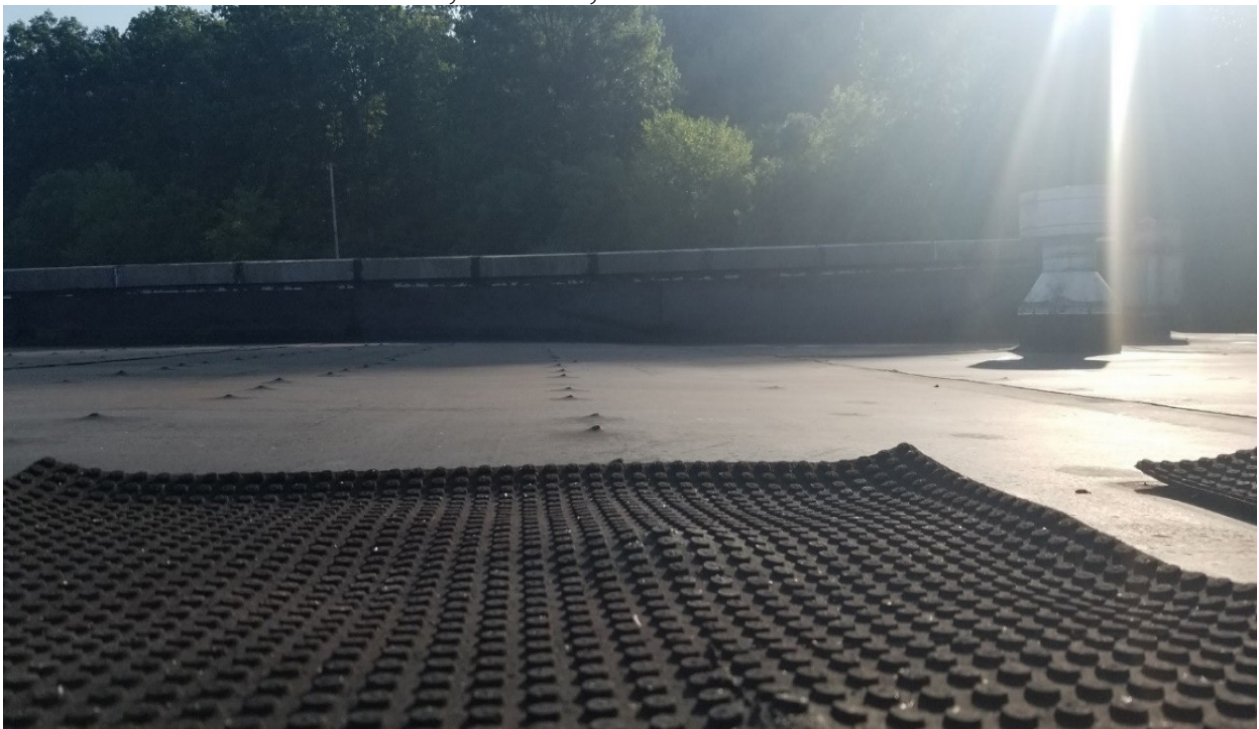
**Figure 18**

Insulation fasteners on the roof at Midway Elementary

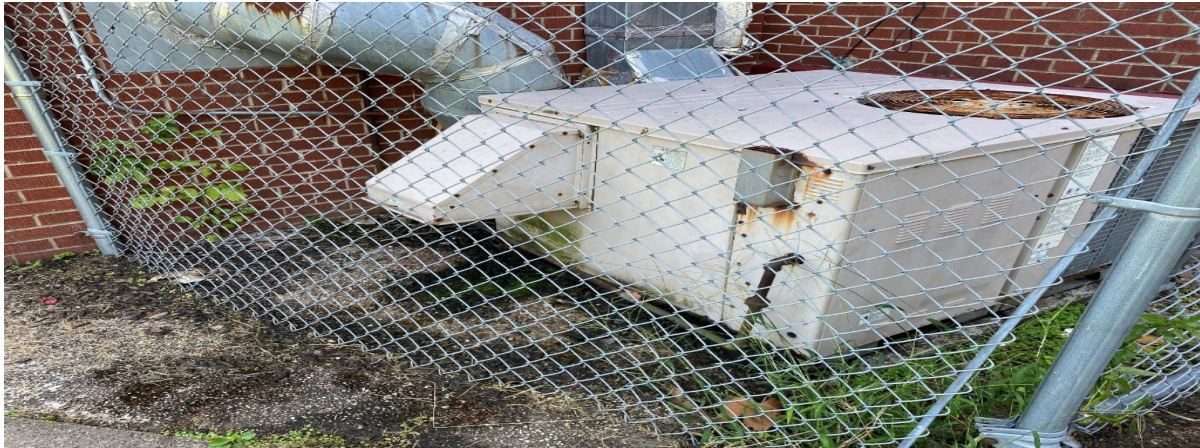
**Figure 19**

HVAC units at Midway Elementary

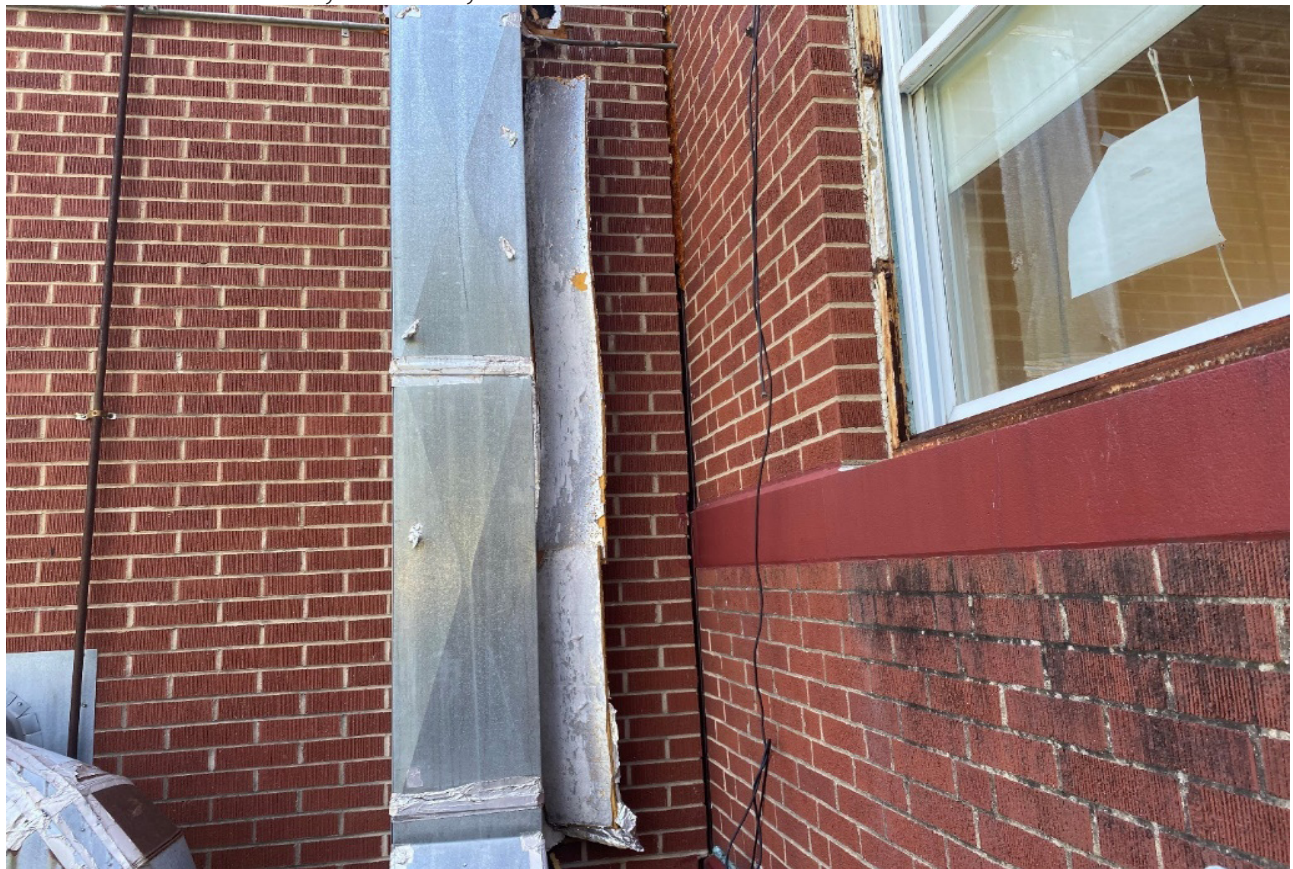
**Figure 20**

HVAC Unit ductwork at Midway Elementary

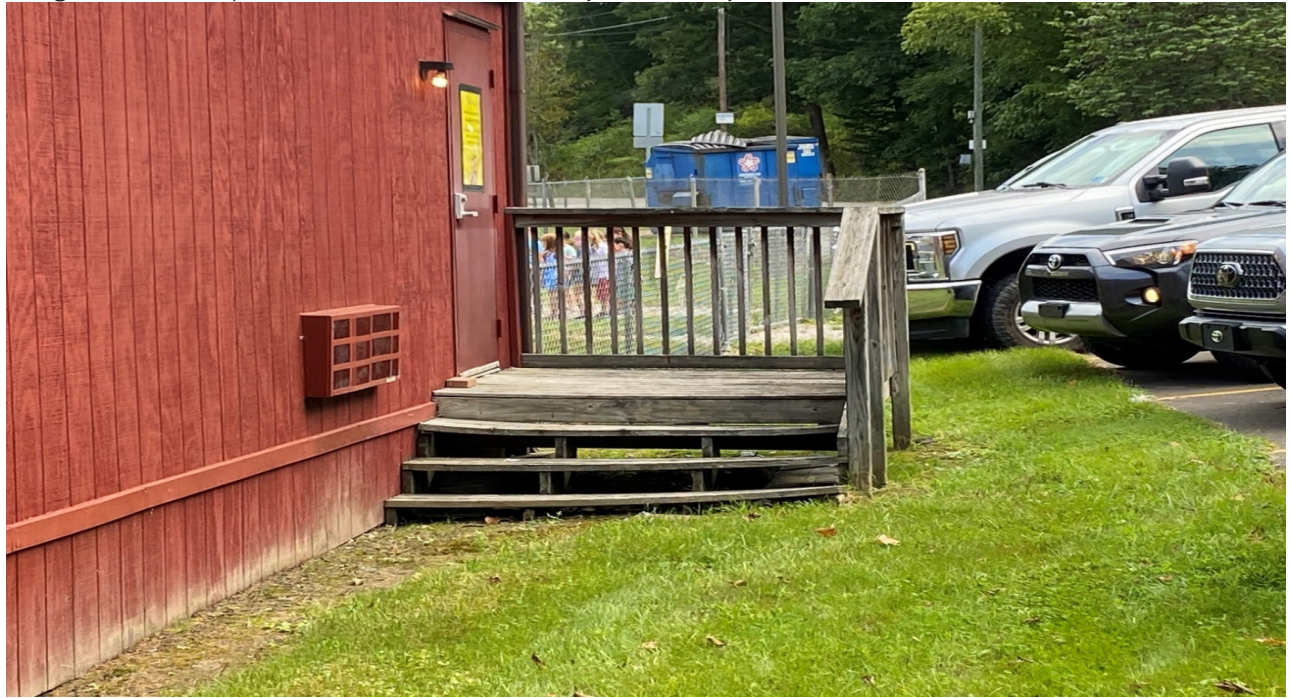
**Figure 21**

Decking and stairs to portable classrooms at Midway Elementary

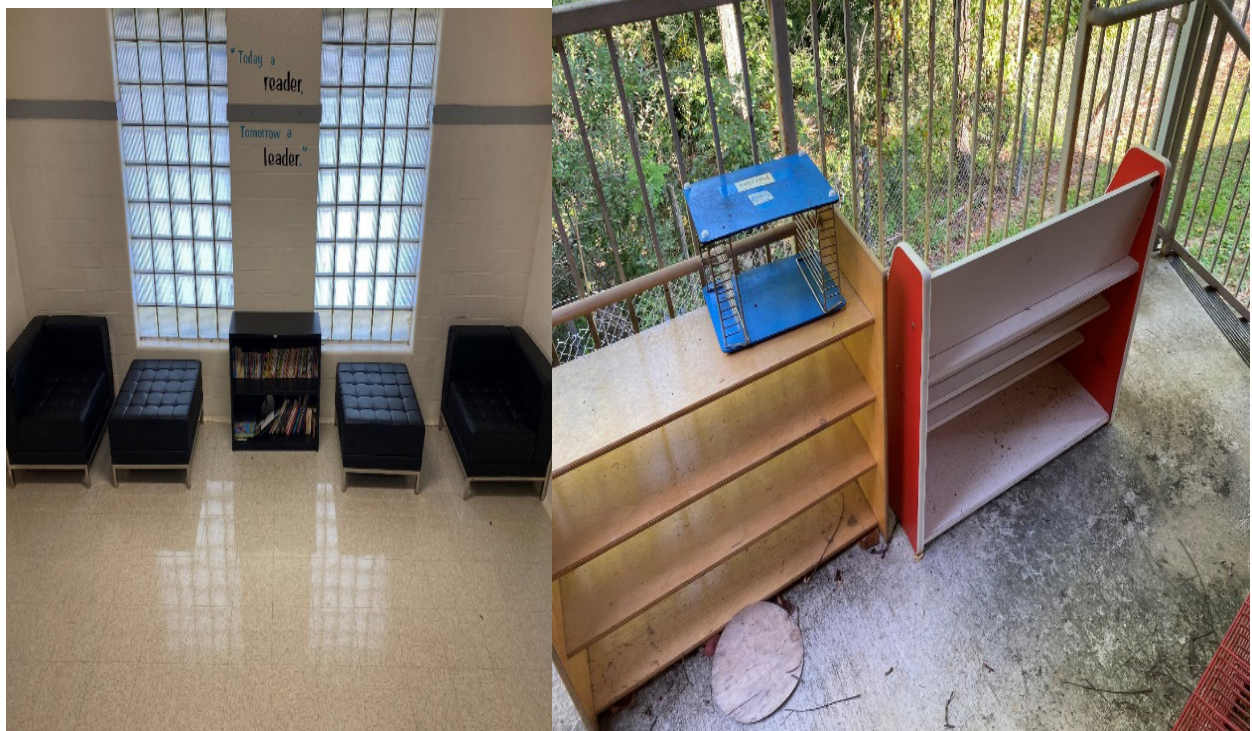
**Figure 22**

Stairwells at Midway Elementary
